Manhole Inspection Summary

Manhole # S35AA1027MH

Insp Date: **1/18/07 10:50 AM**

Location Address: **320 UNIVERSITY PKWY**

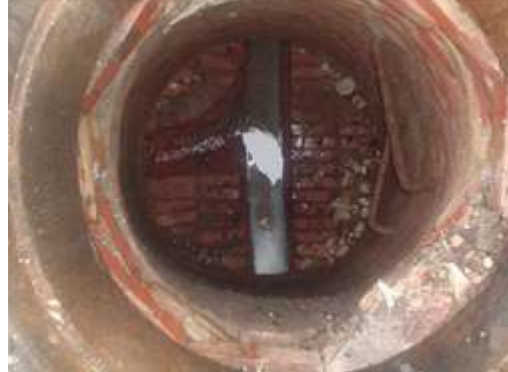
Top View

Corroded steps. Evidence of surcharge - Bench debris.

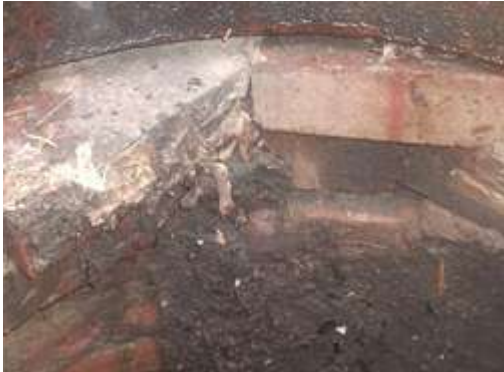
Defect

Frame leaks. Adjustment deterioration and infiltration. Corbel infiltration.

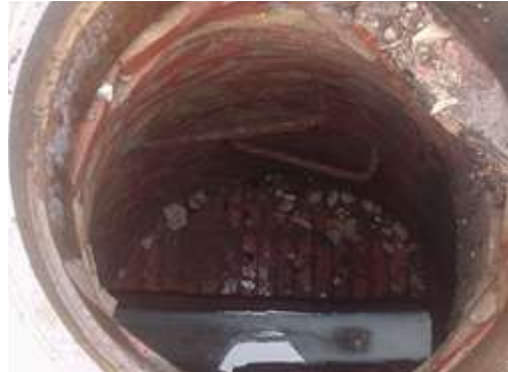
Defect

Frame leaks. Frame offset. Adjustment deterioration and infiltration. Corbel and Barrel infiltration.

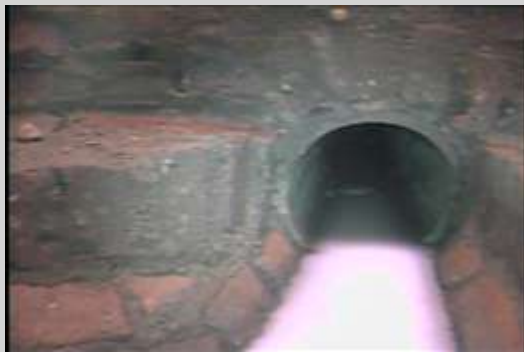
8 in. Circular Gravity Sewer Pipe Out @ 12 O'Clock

Invert Depth: **7.96** (ft.) Flow Characteristics: **Slow**

Infiltration: **None** Pipe Seal Cond: **Sound**

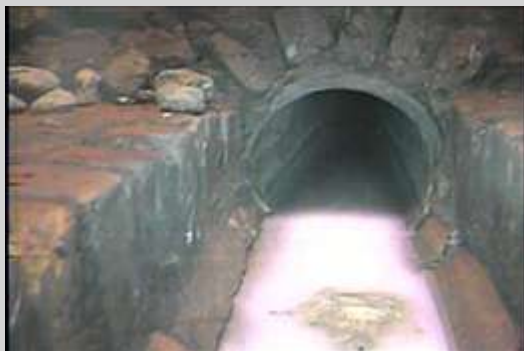
8 in. Circular Gravity Sewer Pipe In @ 6 O'Clock

Barrel deterioration and infiltration. Channel deterioration.

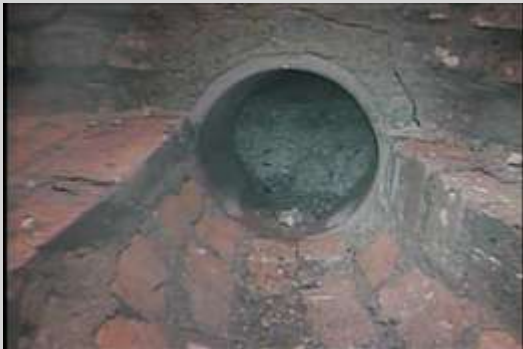
8 in. Circular Gravity Sewer
Pipe In @ 9 O'Clock

Deposits: ☐ None ☐ Mud ☐ Sludge ☒ **Debris** ☐ Grease

Silt Depth: **1** (in.) Deposits Extent: **Light**

Connects To: **Stub connection / abandoned**
